Advisory Region Bridger Range Longitude -110.93W Latitude 45.84N

Forecast link: <u>GNFAC Avalanche Forecast for Sun Apr 3, 2022</u> Bridger Range, 2022-04-03

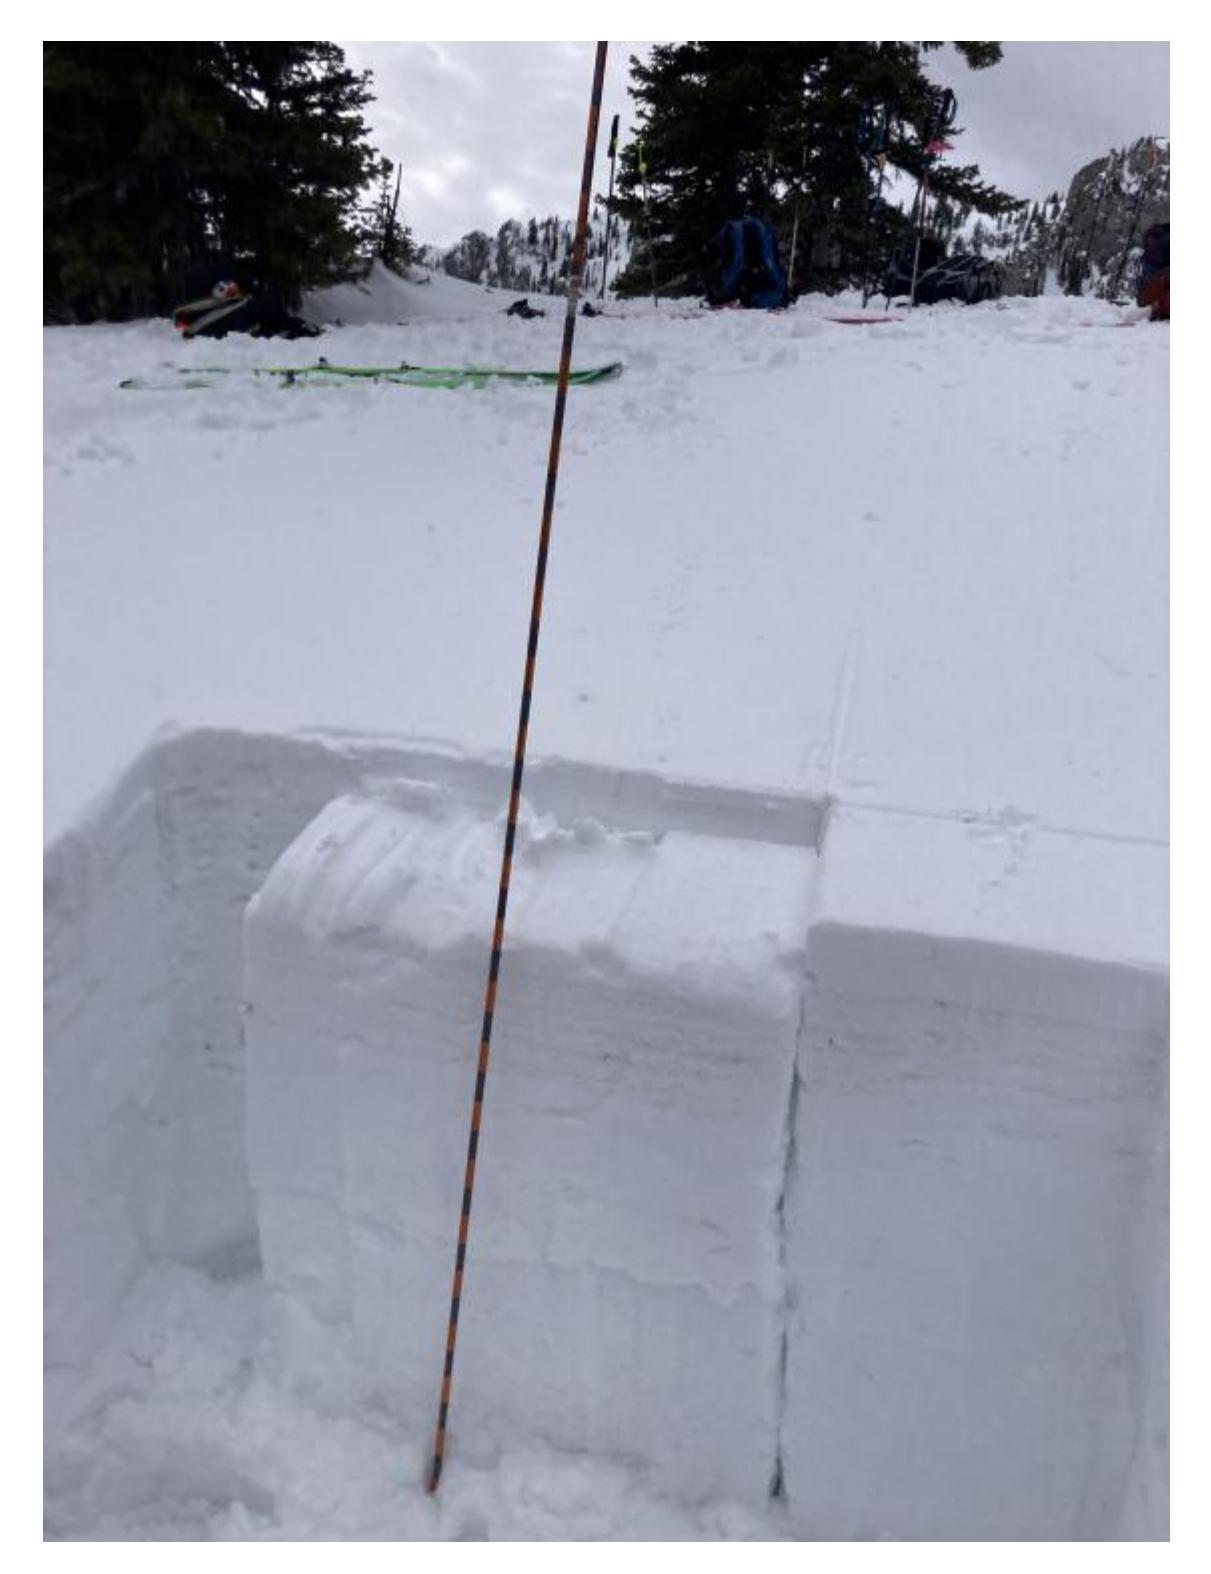
From obs 4/2/22: "With the MSU Avy 2 class today. We dug 3 separate pits on the NE aspect off the top of Texas Meadows. Two pits had ECTX and one in between had an ECTP23 @ 55cm down failing on a persistent facet layer. Bottom half of the entire snowpack was still facets to the ground. Boot sunk to the ground once we reached that layer in the pit." Photo: C. Ellingson
