Advisory Region Northern Gallatin **Forecast link:** <u>GNFAC Avalanche Advisory for Thu Dec 2, 2010</u> Northern Gallatin, 2010-12-01

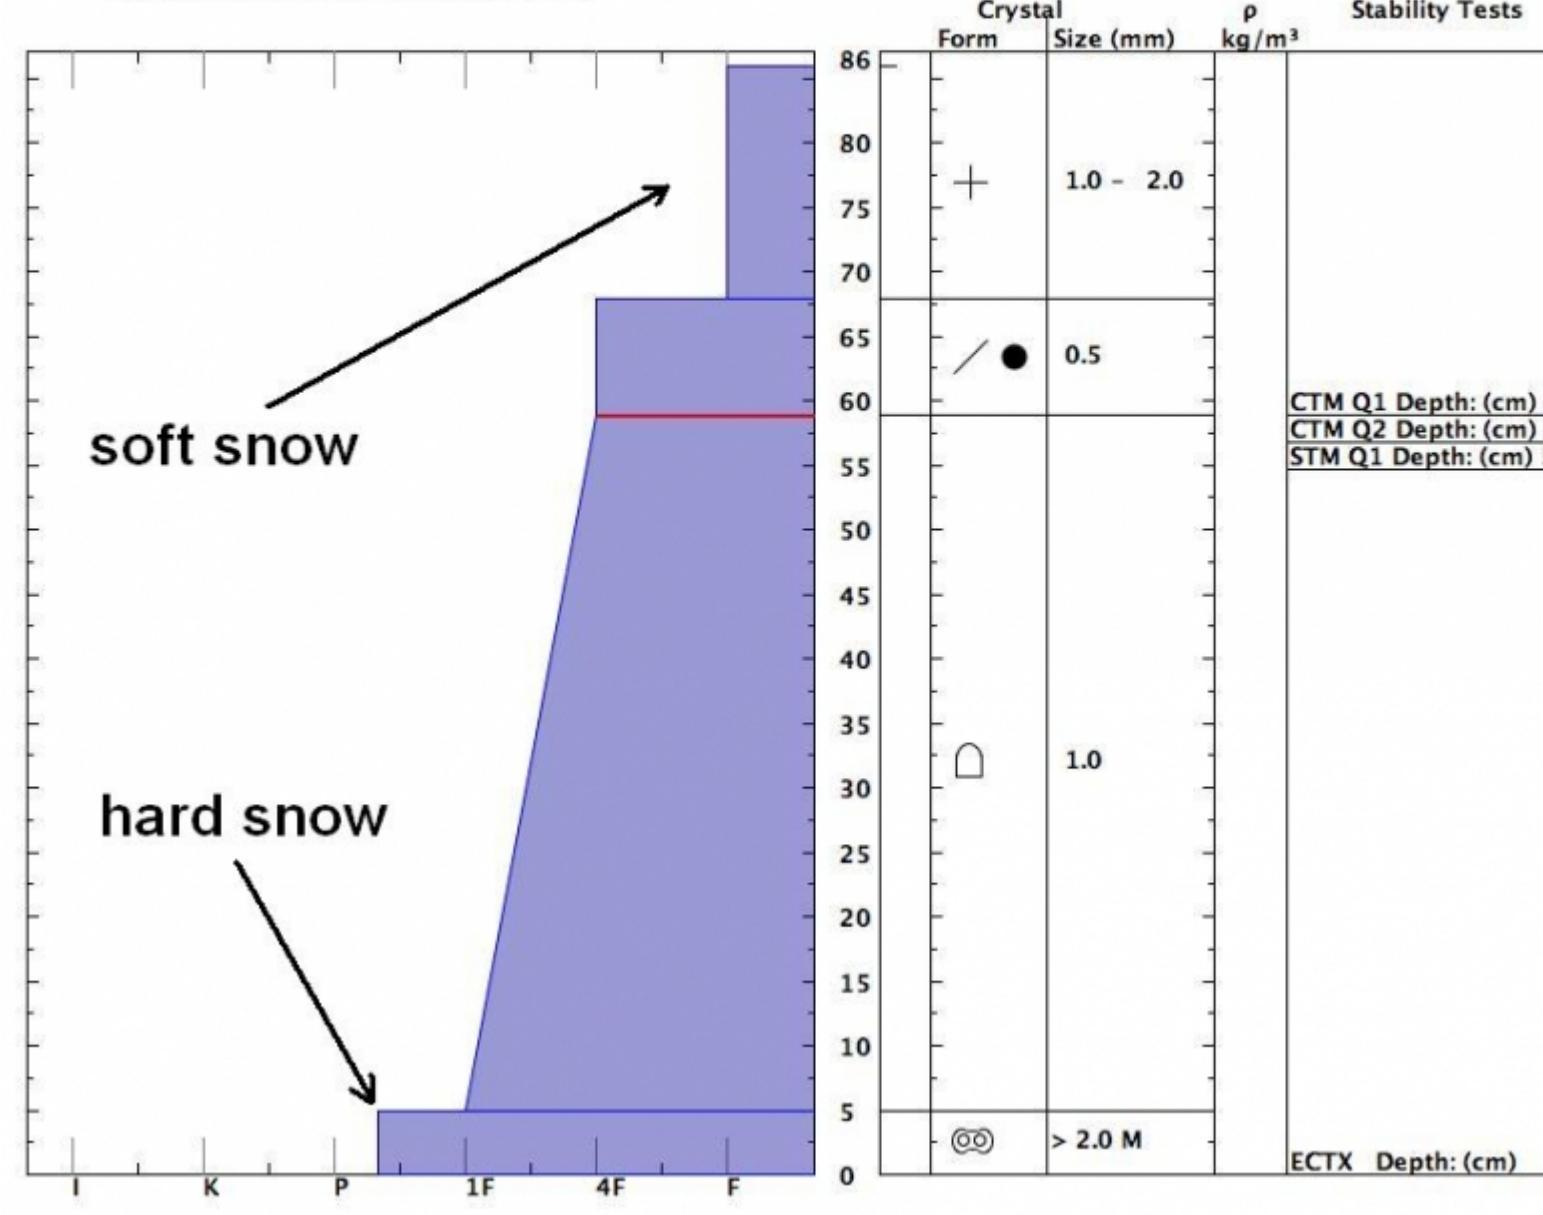
This snowpit was recorded in the northern Gallatin Range just east of Hyalite Canyon. Notice the strong, hard snow near the ground and soft, low density snow near the surface. Stability tests show fractures about 10 inches down. While not a problem in this snowpit, they would be a concern if a denser wind slab were deposited on top of this snowpit. Image: A. Marienthal
